Diagnosis of internal defects from acoustic images 9/25/2000

By Tom Adams

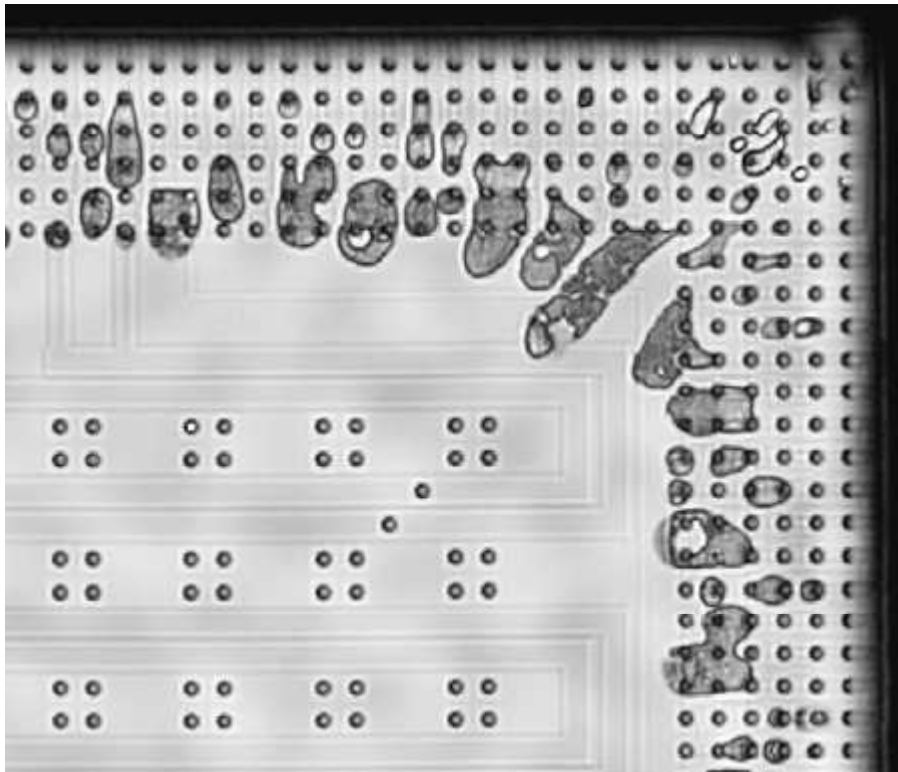
Variable underfill flow speed [Figure 1]

Figure 1 is the acoustic image of one corner of a flip chip package. Higher ultrasonic frequencies yield higher resolution, and here (as is often done with flip chips) the very high frequency of 230 MHz was used.

There are no missing solder bumps, although one bump in a group of four just left of center is much brighter than the others, indicating high reflection (and therefore a gap) where there should be a bond to the die face.

There are also numerous large voids (the irregular gray areas). Their orientation and location give clues to their formation: as the fluid underfill flowed around the solder bumps, it slowed down. In some areas, this slowing allowed pockets of air to be surrounded and pinched off. After the fluid underfill material traveled beyond the densely arranged peripheral solder bumps, void formation stopped.

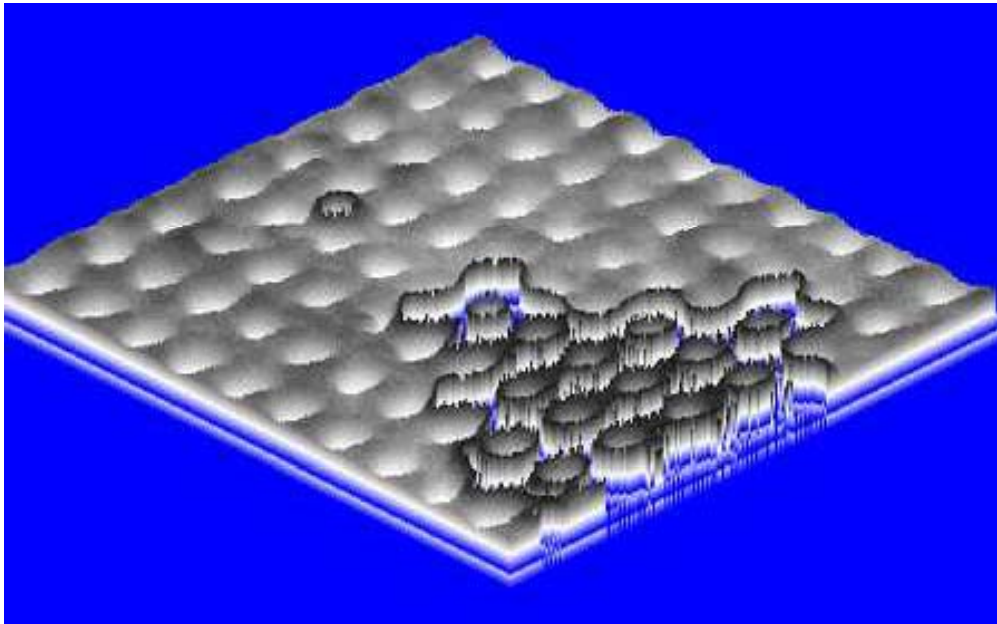
Insufficient quantity of fluid underfill [Figure 2]

In Figure 2, there is a single small void at left, and a second "gap" area at right that is too large to have been formed by the pinching off of an air bubble. Instead, this area represents an underestimate of the amount of fluid underfill needed to fill the offset between the chip face and the substrate. The design of the dispensing pattern for the fluid underfill may be correct, but there isn't enough material to go around.

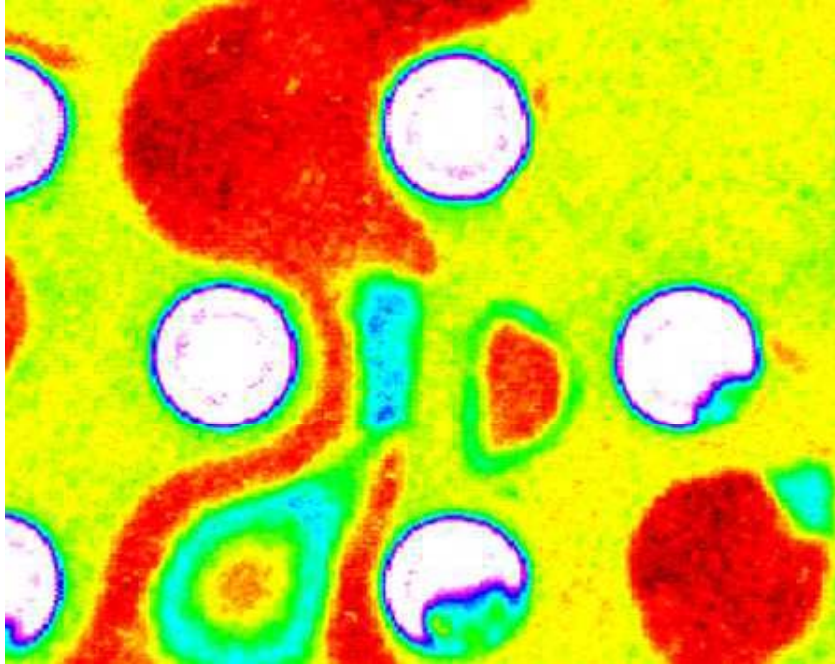
BGA with underfill [Figure 3]

Figure 3 is a magnified view gated acoustically to use only the return echoes from the interface between the solder bumps and the substrate. This BGA displays multiple anomalies. First, the expected bright circular reflection is missing from two of the solder bumps, which are only partly bonded to the substrate. One likely cause is surface contamination during reflow.

In addition, the dispersal of filler particles in the underfill material is uneven (yellow and green areas). The red areas are voids - areas with no underfill material at all.

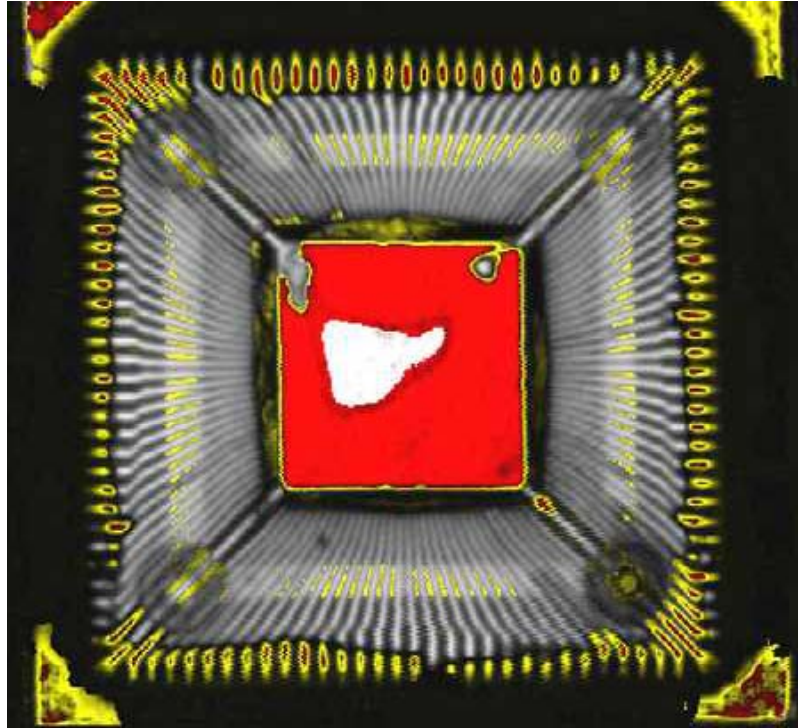
PQFP with peripheral leadframe delaminations [Figure 4]

Imaged from the bottom side, this PQFP shows two defect types. First, most of the die is disbonded (red) from its paddle. Only the white area is bonded. Surface contamination of the die paddle is one possible cause of disbonding.

Second, nearly all of the lead fingers are delaminated (red, yellow) from the molding compound, but only at their outer limits. A delamination here opens a pathway for environmental contaminants. One cause of such a peripheral pattern of delaminations is mishandling during trim and form - but that cause can be discounted here because the PQFPs are still in strip form and not yet singulated. Portions of the strip are visible as triangular features at the top and bottom of the image.

Other causes of this delamination pattern include oxidation from bonding temperatures, and warping of the leadframe when processes do not permit adequate stress relief.

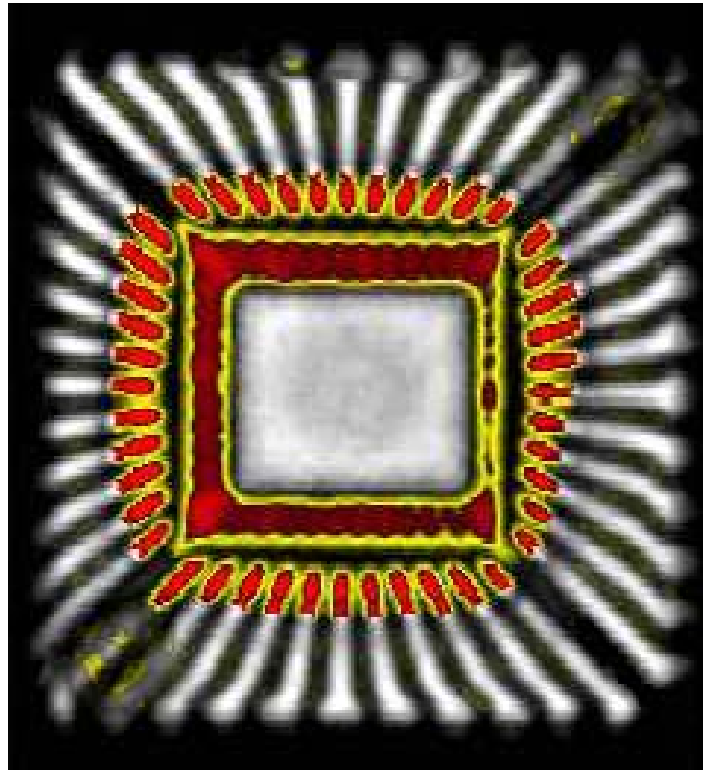
Lead finger delamination related to tinning [Figure 5]

This PLCC suffers from two defects. First, the dark red area around the die is a large delamination of the paddle from the molding compound.

More interesting, though, is the delamination of every lead finger at its inner end. This is where the lead fingers are tinned to improve wire bonding, but the tinning material needs to be compatible with the molding compound material. Some tinning materials - usually gold and other noble metals - don't form good bonds with some molding compounds. The pattern of delaminations suggests that such a mechanism may be operating here.

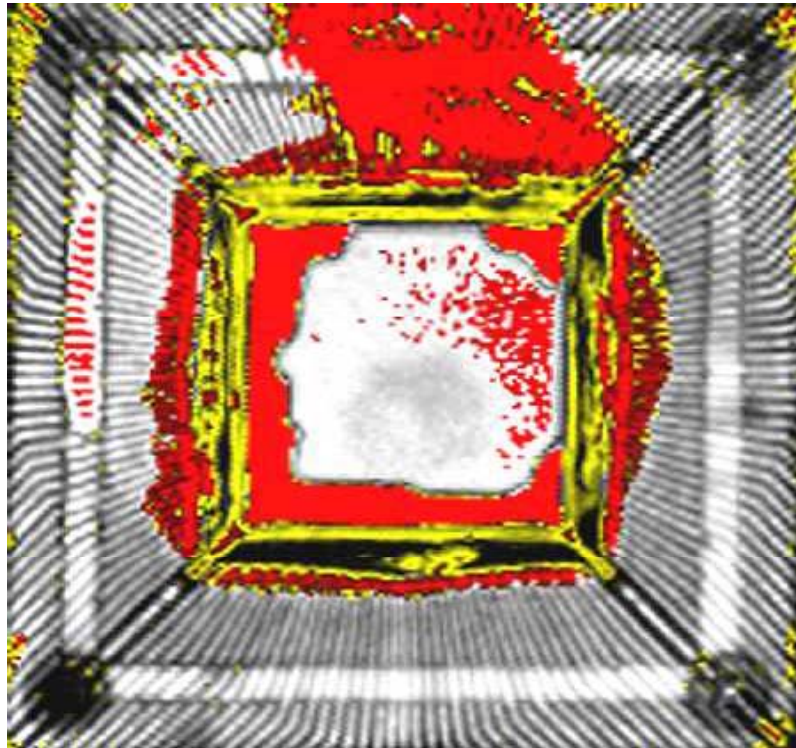
PQFP with multiple defects [Figure 6]

This PQFP was imaged acoustically from the topside and with rather wide gating which encompasses depth from just above the die face downward to the die paddle. The red areas in this image actually define three separate and possibly unrelated internal defects:

- The red area surrounding the die, and extending to the top of the image, is a large "popcorn" crack. Popcorn cracks often occur during reflow when excess moisture in the molding compound is heated and expands.
- The solid red area around the periphery of the die indicates partial disbond of the die from the die paddle. One possible cause: surface contamination. The gray-white area is the well-bonded area of the die attach.
- The smaller red spots within the well-bonded area are small delaminations between the die face and the molding compound above it. They are visible here because of the unusually wide gating of the return echoes.
